TCEQ Interoffice Memorandum

Subject: Request for Region to Investigate F.J. Doyle Salvage Facility located at (b) (6) (b) (6) (905 N. Poplar Street), Leonard, Fannin County, Texas
TCEQ SWR No. 80951; EPA ID No. TXD980865109; Customer No. CN600359095;
Regulated Entity No. RN100649227

Site Background

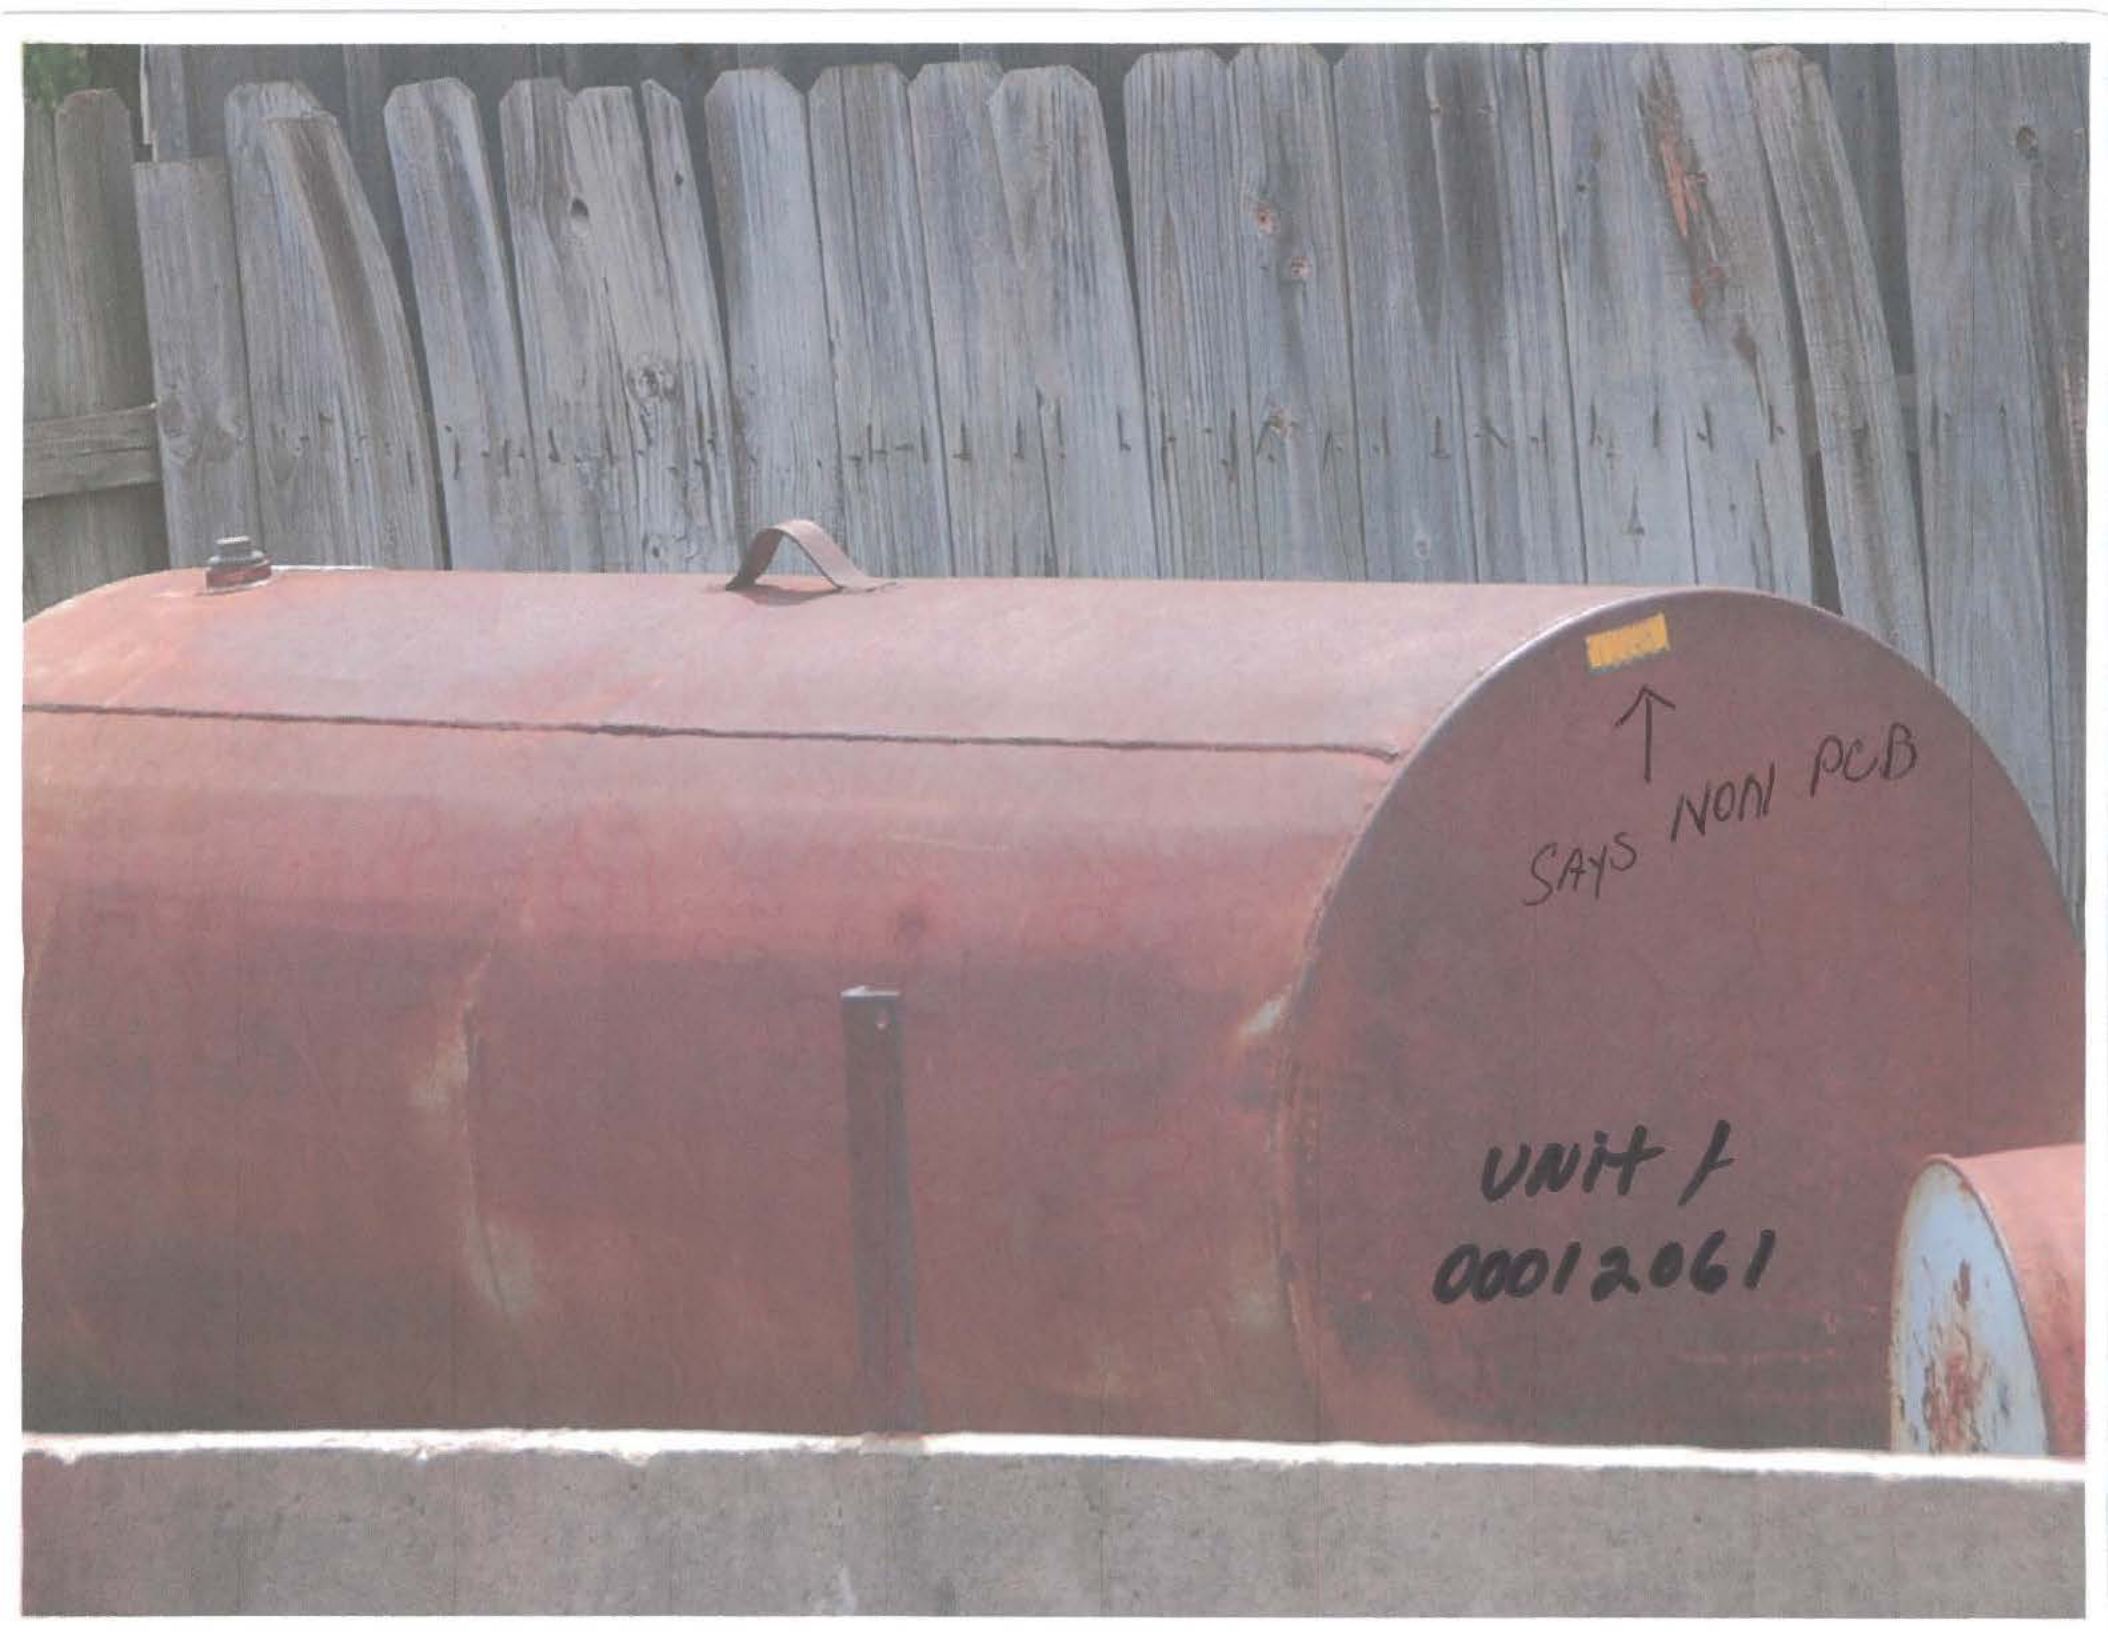
Unit 1
00012061

A photograph of a large, rusted metal drum, likely a hazardous waste container, positioned in front of a weathered wooden fence. The drum is reddish-brown with visible rust and a small metal cap on top. On the right side of the drum, there is a yellow rectangular label with an arrow pointing to it. Below the label, the words "SAYS NON PCB" are handwritten in black marker. Further down, the text "UNIT 1" and the number "00012061" are also handwritten in black marker. A concrete curb is visible in the foreground, and a portion of another drum is visible on the right edge.

↑
SAYS NON PCB

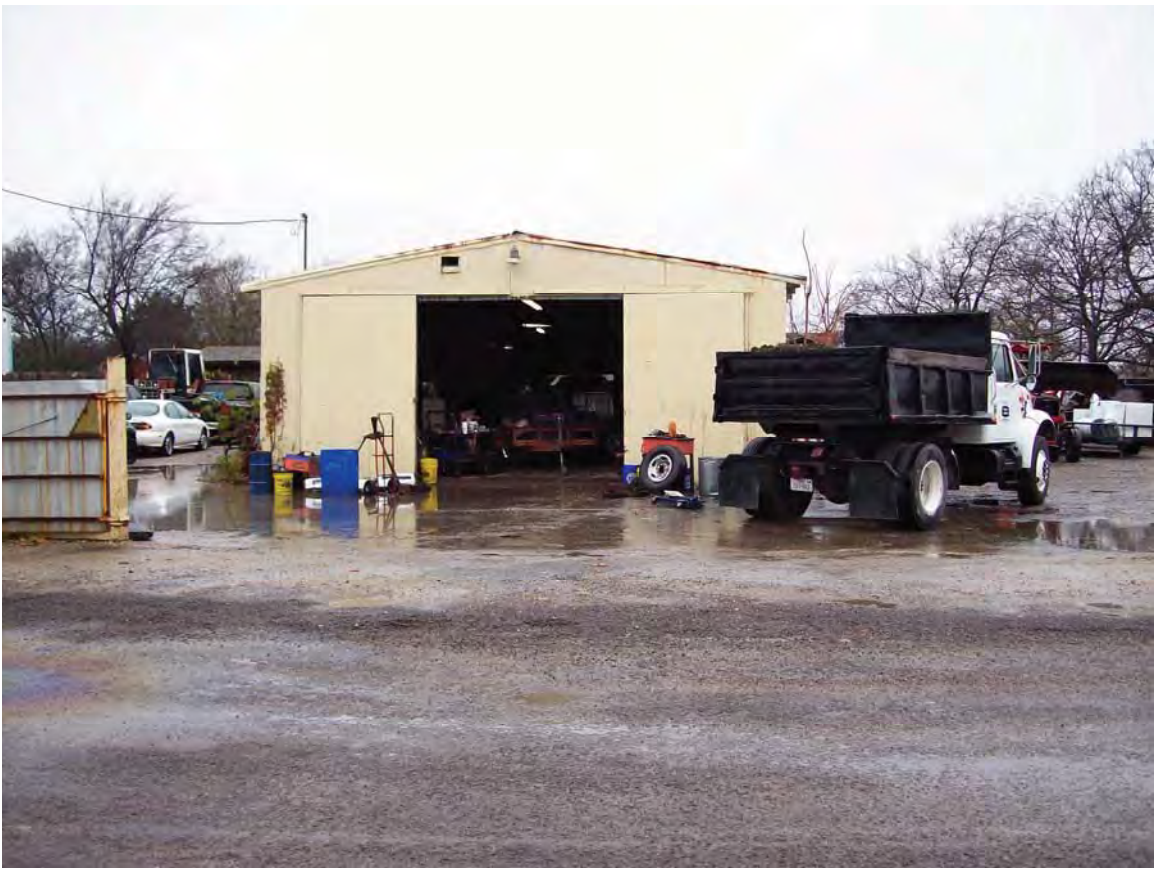
Photograph 1: View looking west of the automobile repair shop building. This building was previously used as the transformer recycling facility.

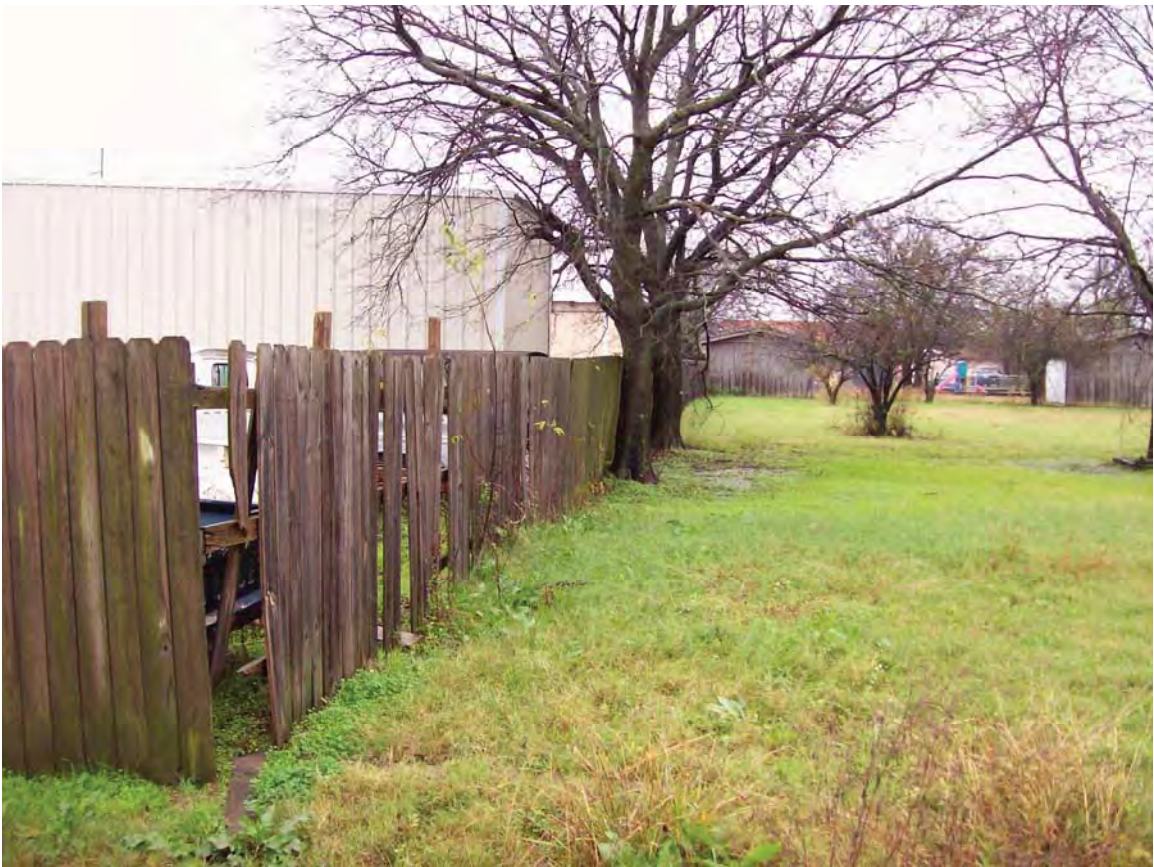
Photograph 2: View looking south of the west property boundary showing the shed (left) and the vacant lot located west of the site.

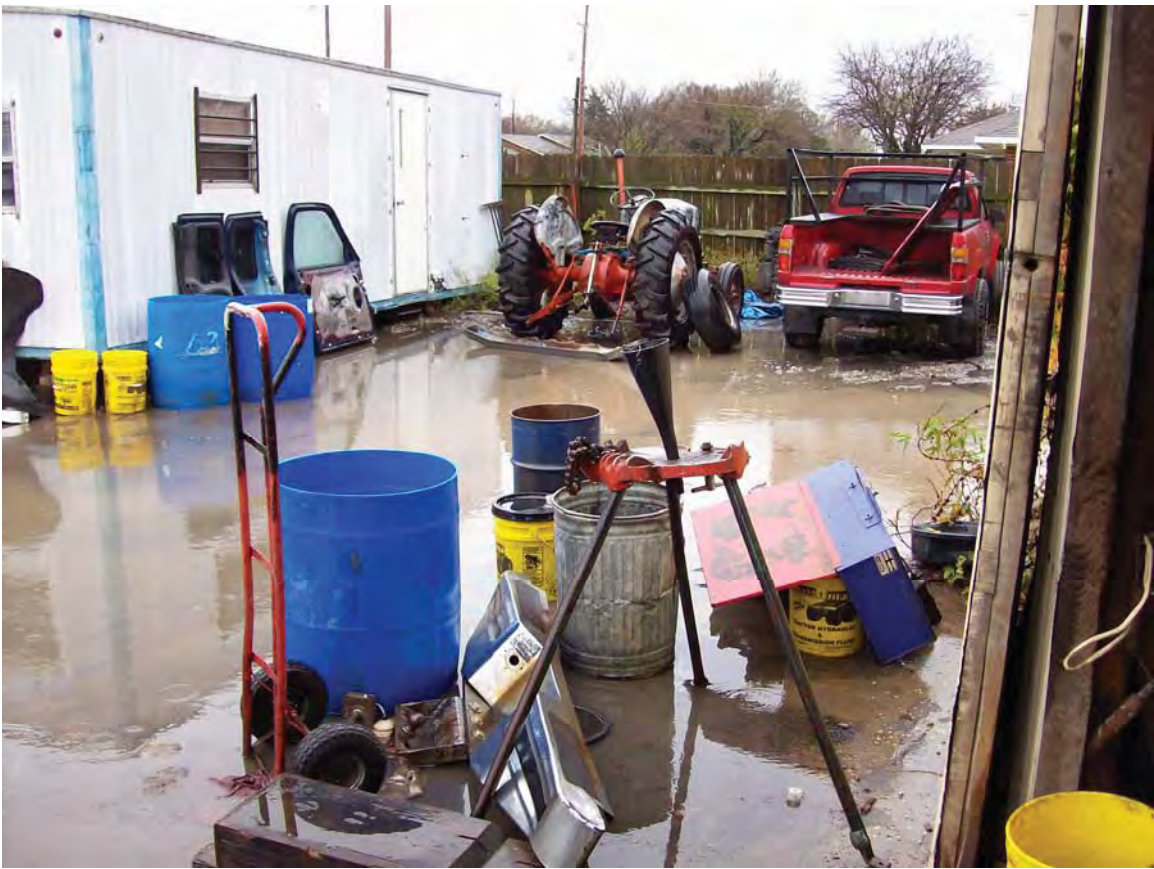
Photograph 3: View looking southeast of the portable building and of the exterior of the automobile repair shop.

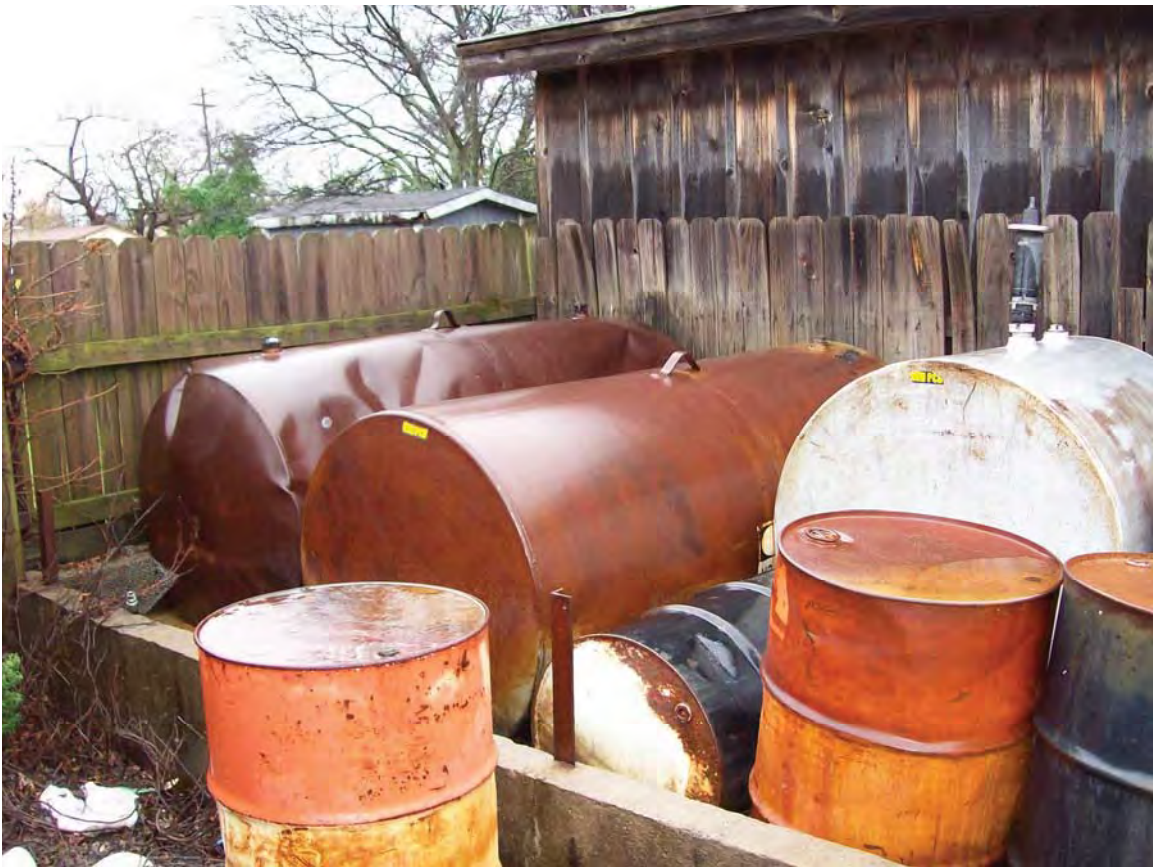
Photograph 4: View looking northwest the three aboveground storage tanks and multiple 55-gallon drums in and near the spill containment sump.

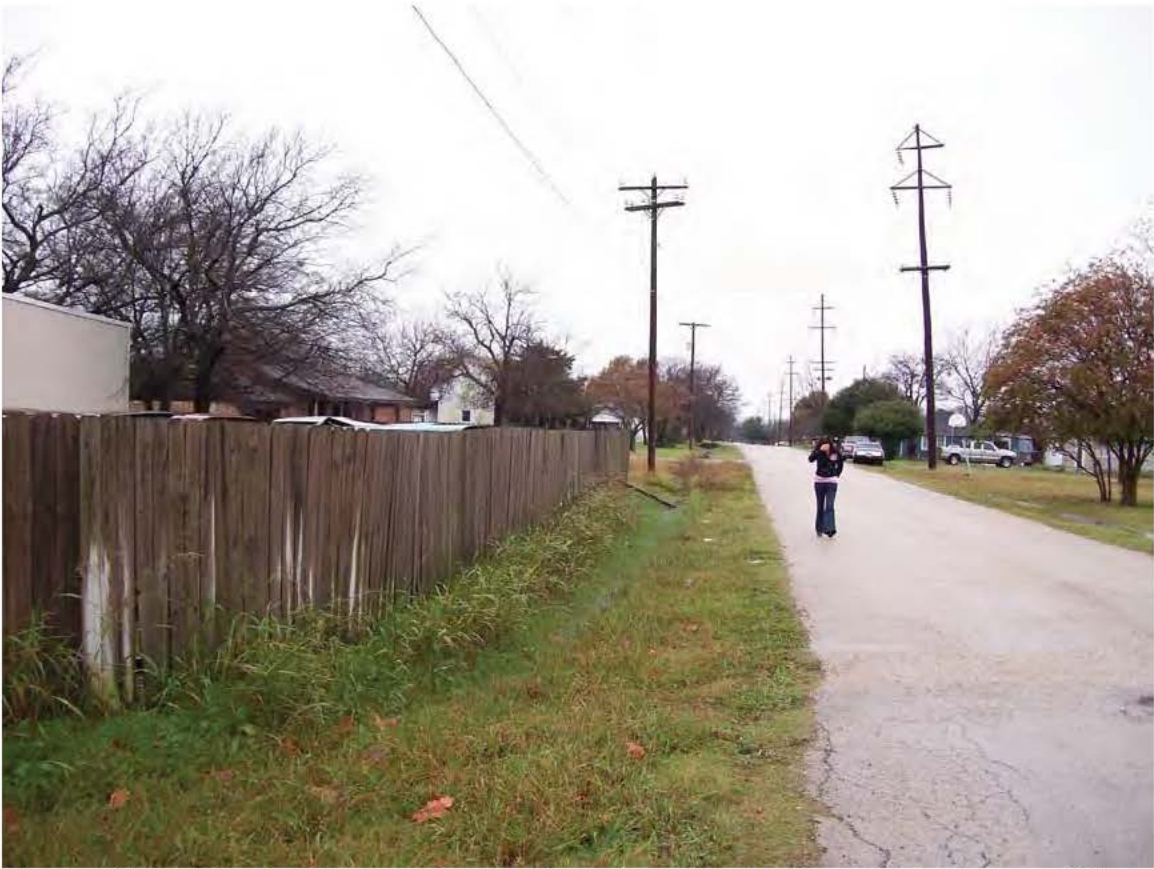
Photograph 5: View looking west showing the northern property line with E. Cottonwood Street and the residential neighborhood beyond.

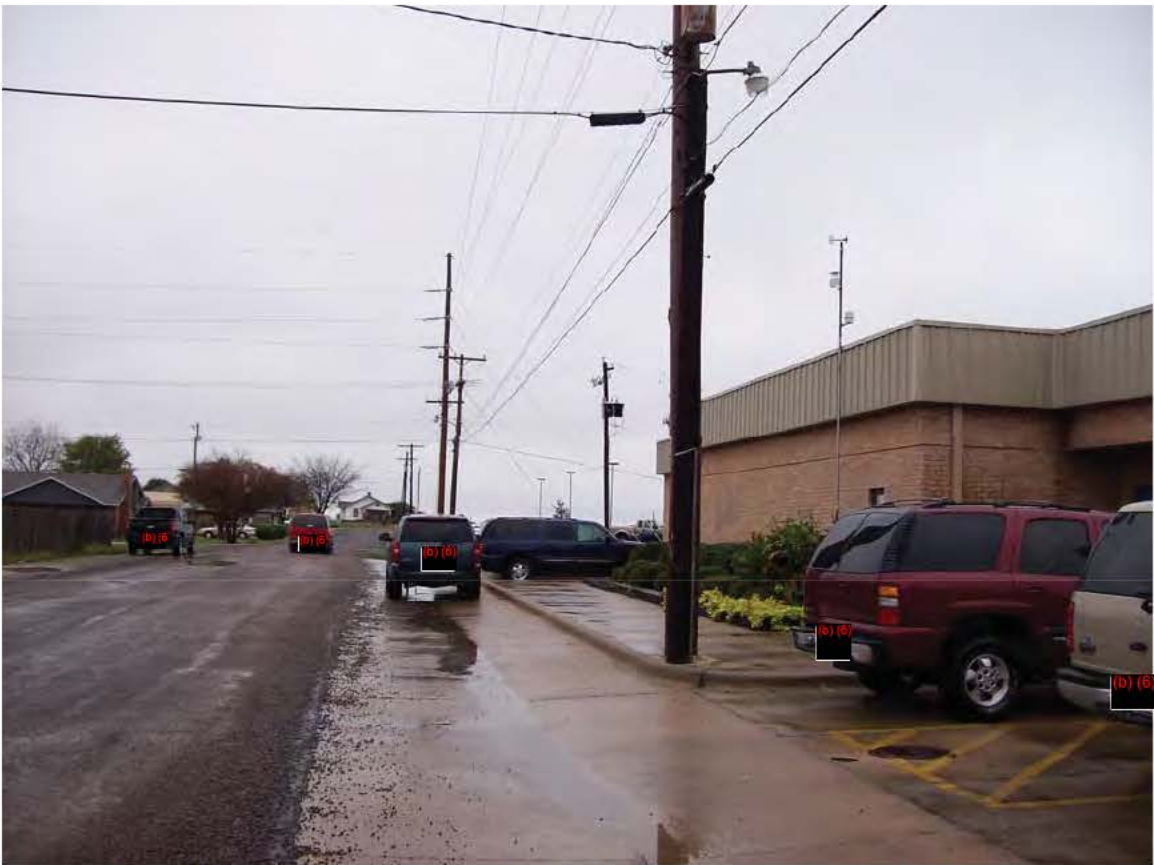
Photograph 6: View looking north along N. Poplar Street showing the school buildings east of the site. Also note the one transformed on the power pole in the foreground (#N6497) and in the three in the background (Nos. N23508, N21884, and N21888).

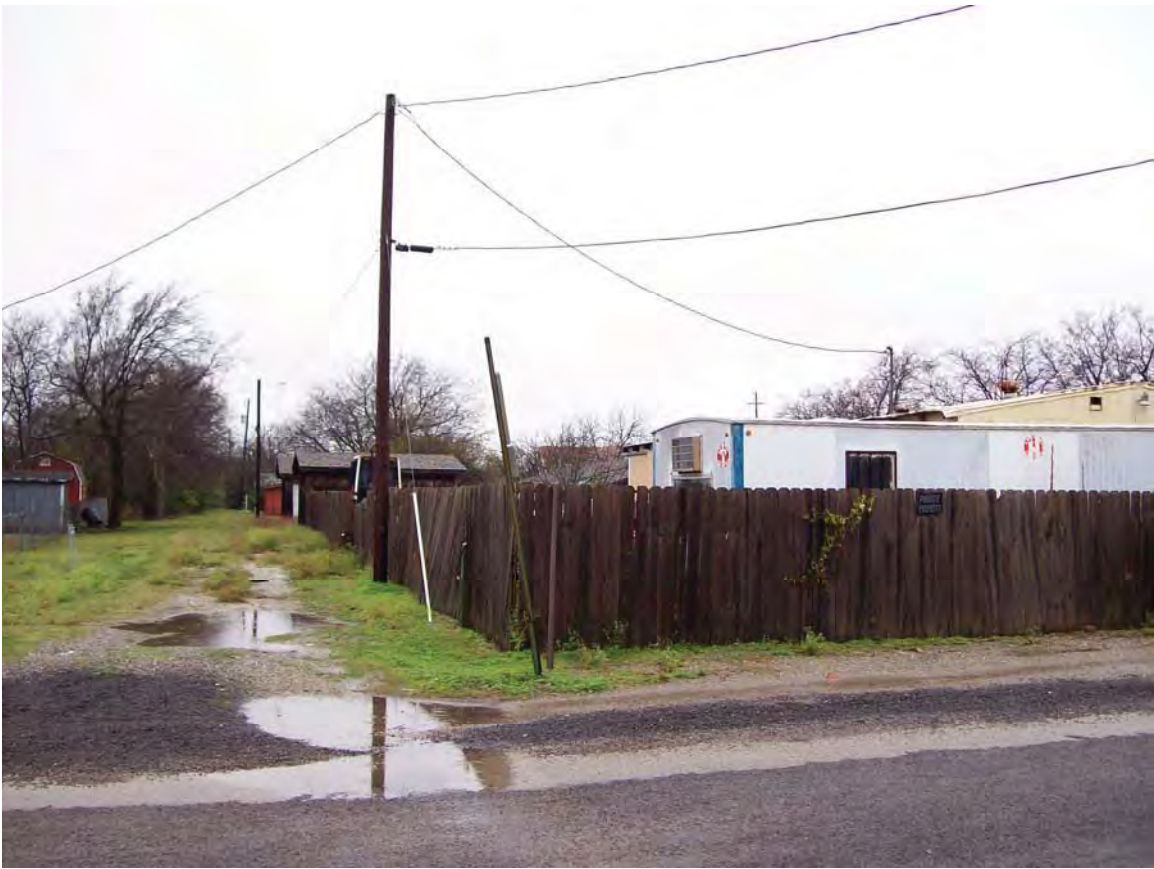
Photograph 7: View looking west of the alleyway south of the site with the residences beyond.

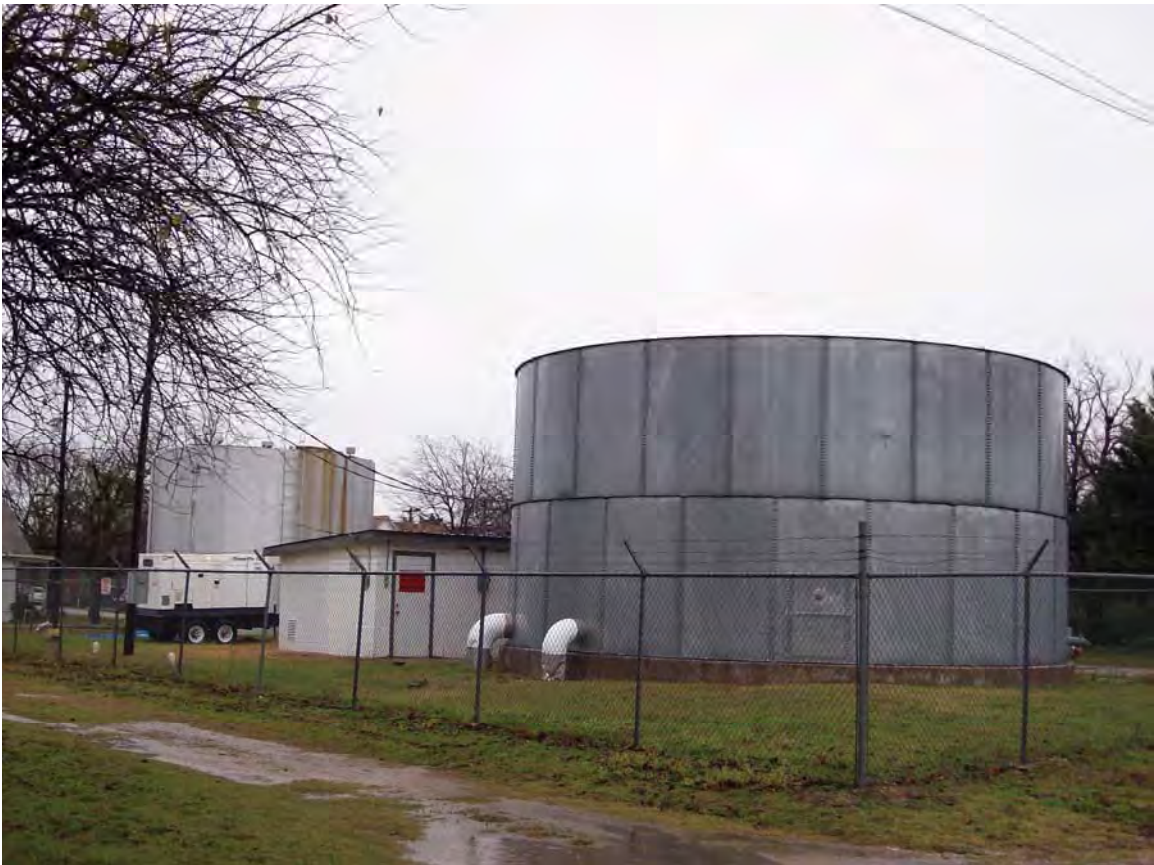
Photograph 8: View looking southeast of City Water Well #1 and its storage tanks located approximately 370 feet from the site

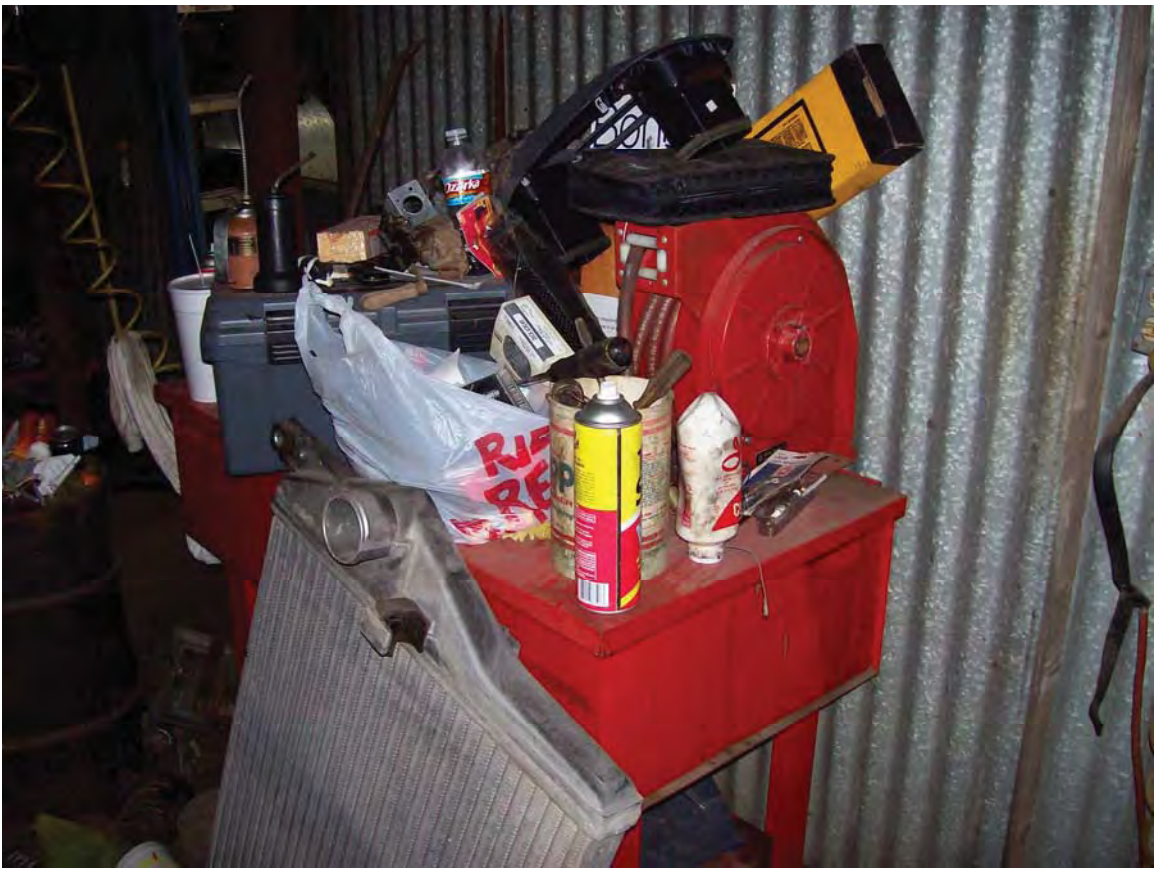
Photograph 9: View inside the shop building showing the parts washer and other chemicals.

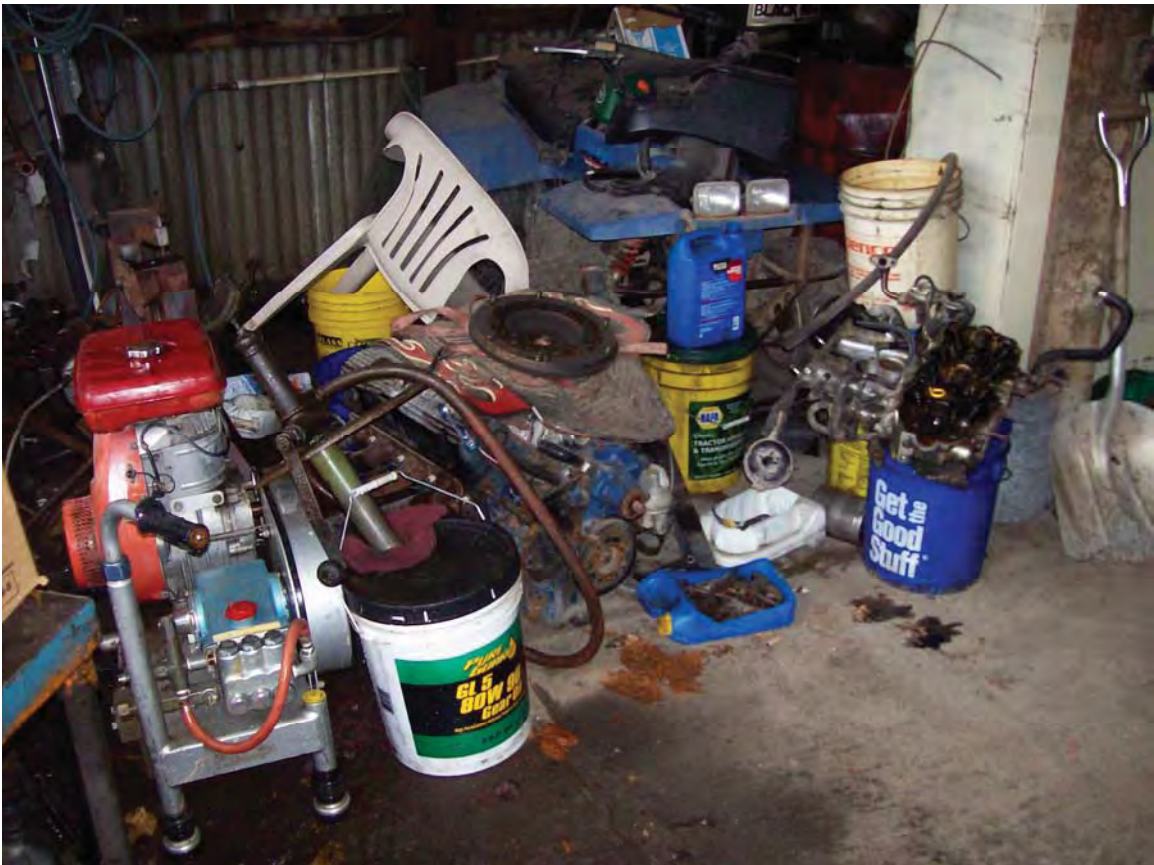
Photograph 10: View inside the shop building showing 5-gallon buckets of chemicals and oil, both new and used. Numerous areas of stained concrete are visible in the shop.

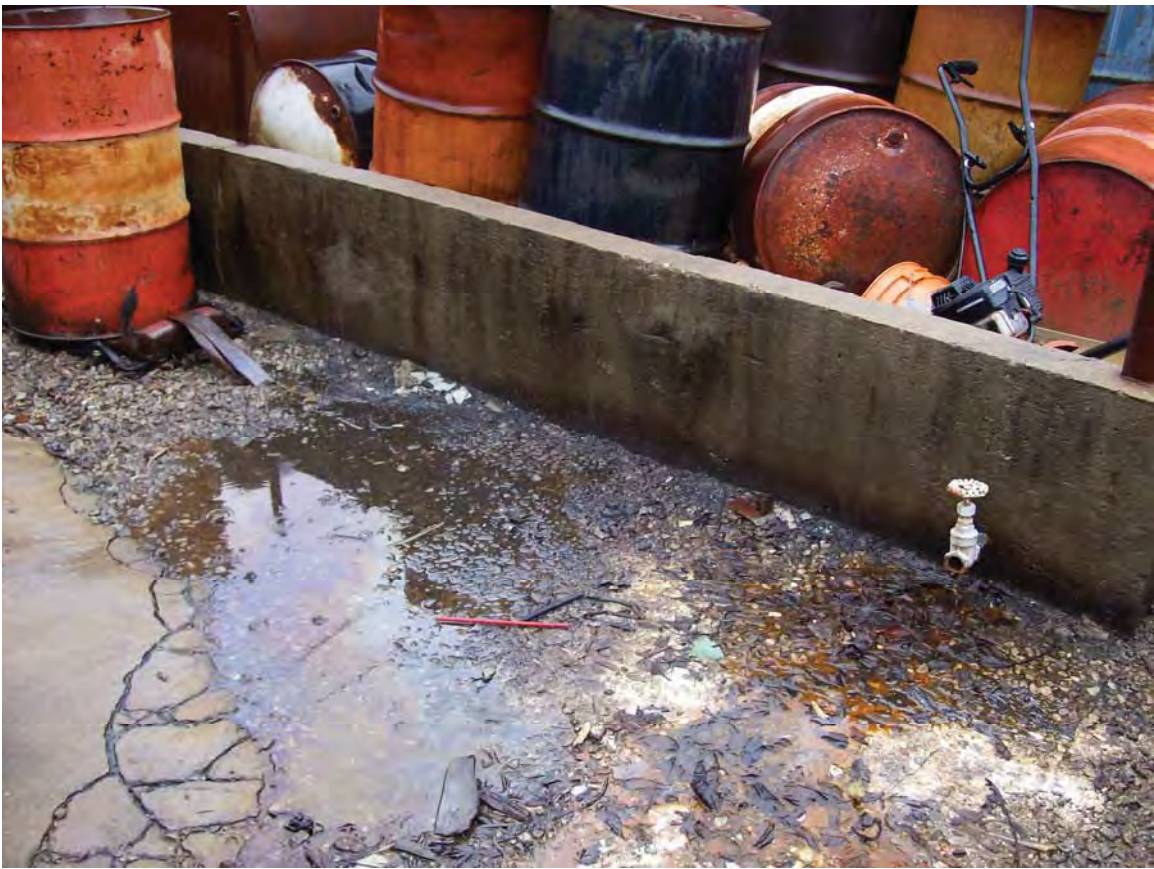
Photograph 11: View looking southwest of the drums inside and outside the AST secondary containment basin. Note the drain valve and the stains and hydrocarbon sheen on the standing water.

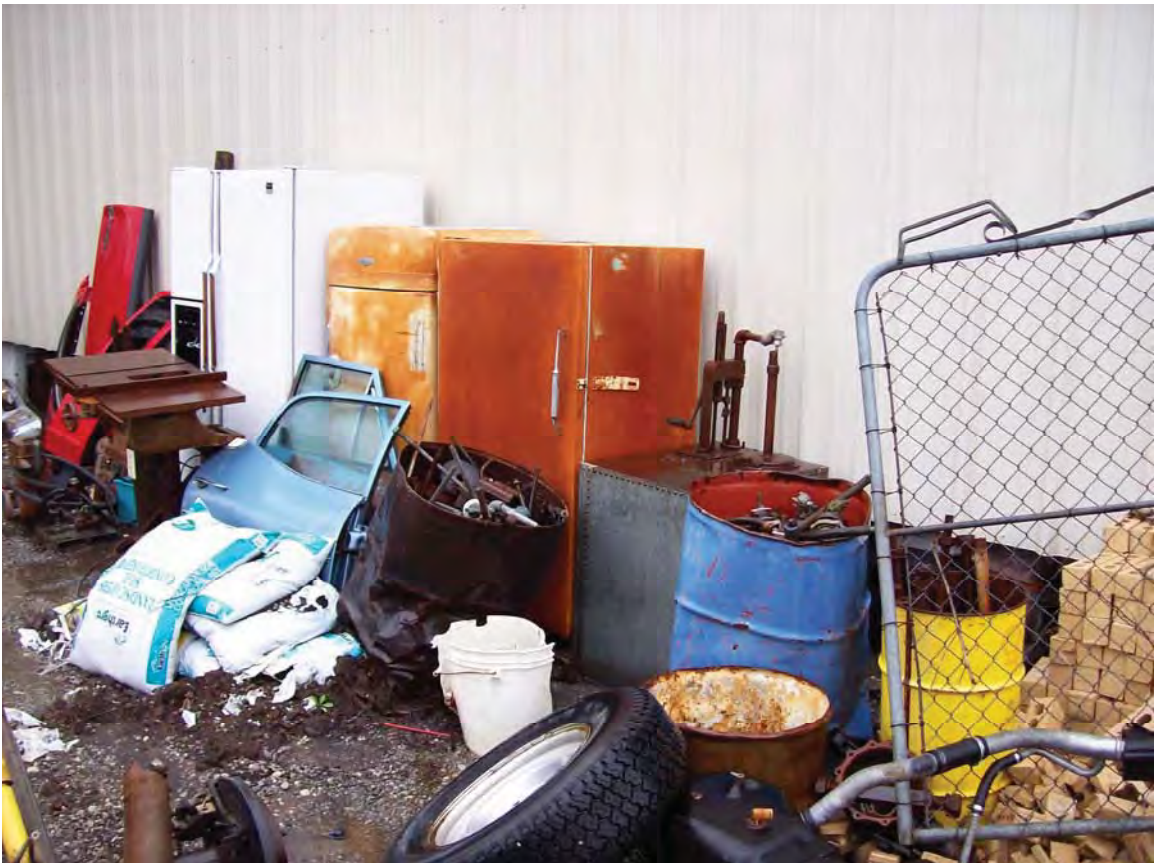
Photograph 12: View looking southeast the kerosene-dispensing AST, drums, and other debris on the north side of the shop building.

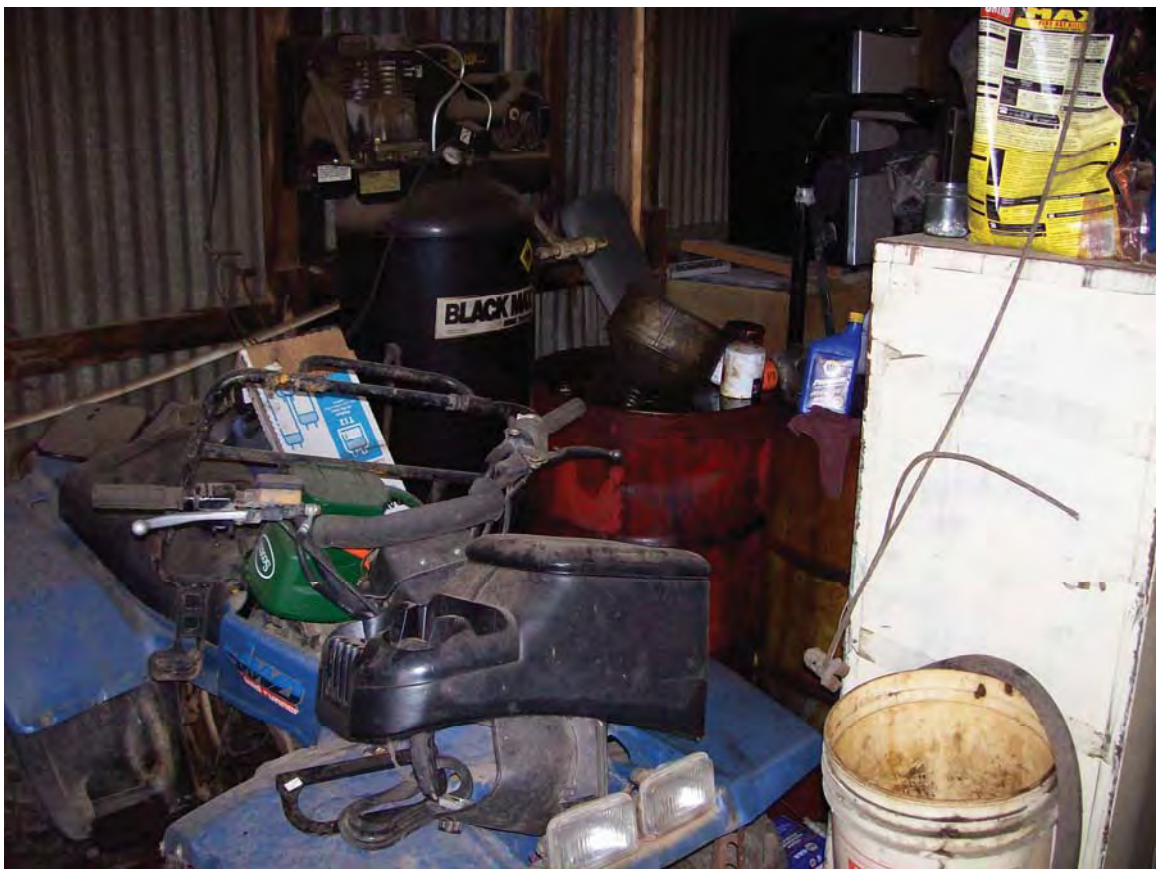
Photograph 13: View inside the shop building of equipment, parts, and new and used oil containers and drums.

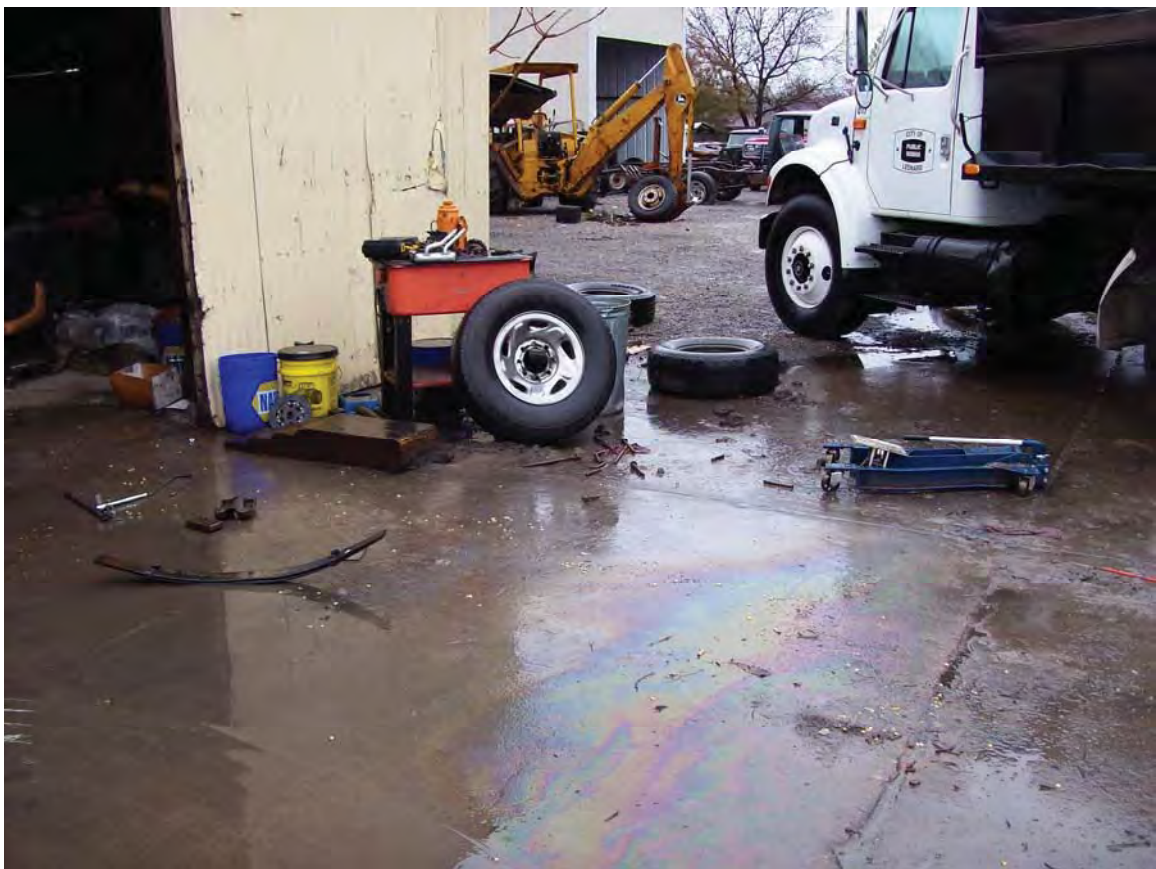
Photograph 14: View looking northwest of the rainbow hydrocarbon sheen visible on the concrete driveway near the shop building.

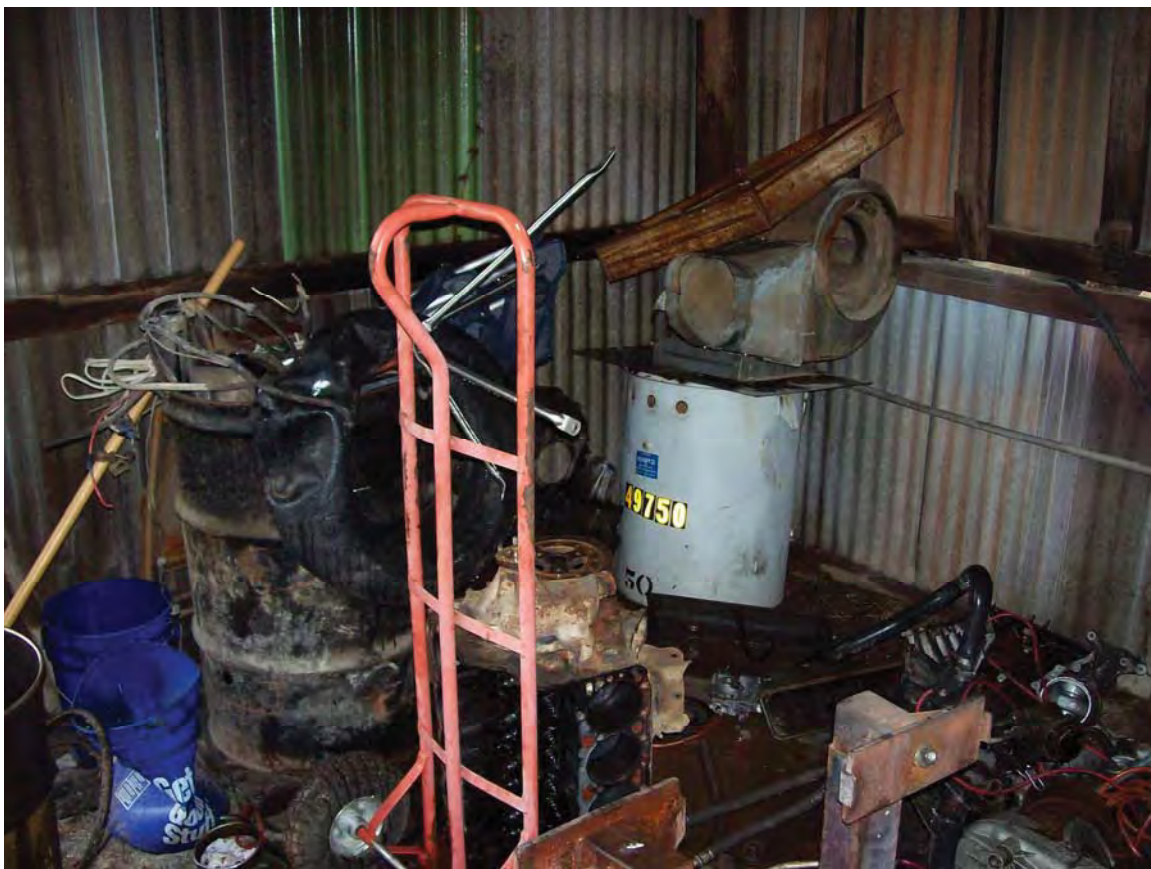
Photograph 15: View inside the shop building showing the leftover transformer from the salvage business. Note the blue "No PCB" sticker on the transformer. This area is where the furnace used for burning the insulation from the transformer was located.

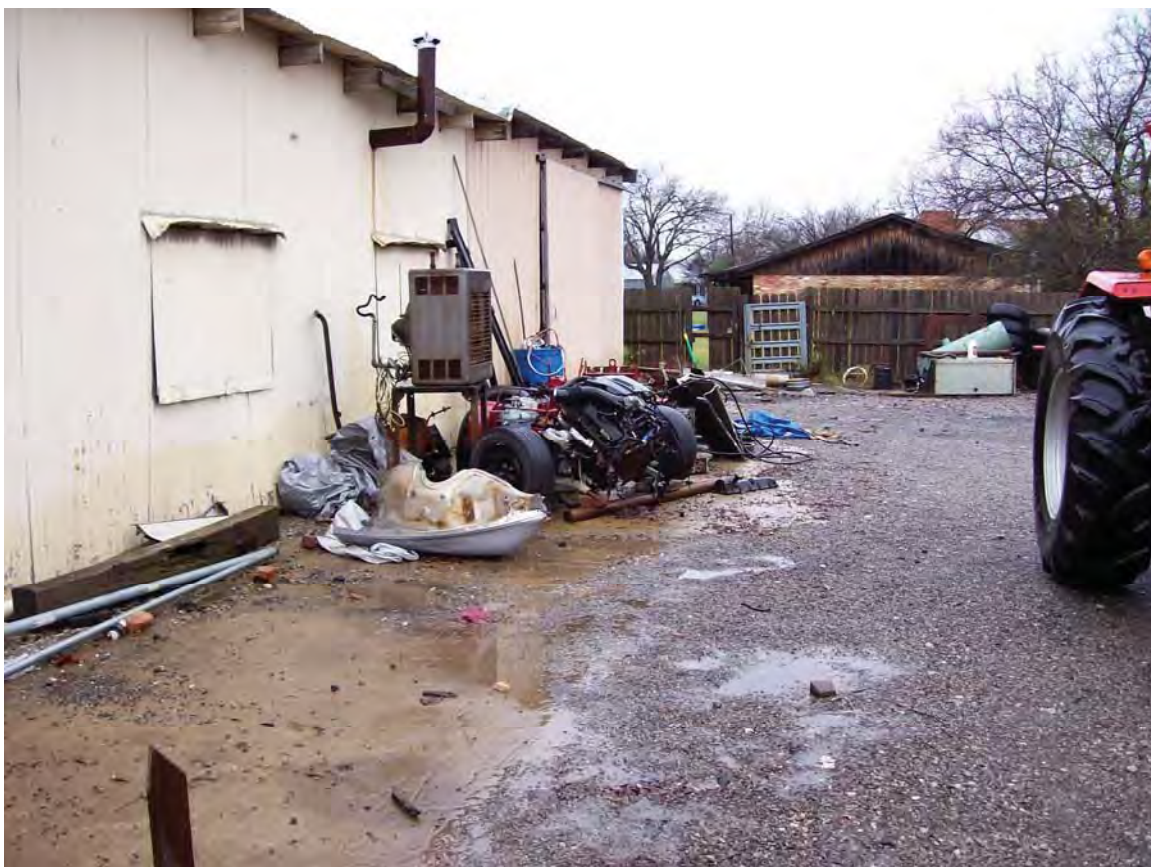
Photograph 16: View looking southwest of the north side of the shop building showing some of the scattered areas of debris and parts.

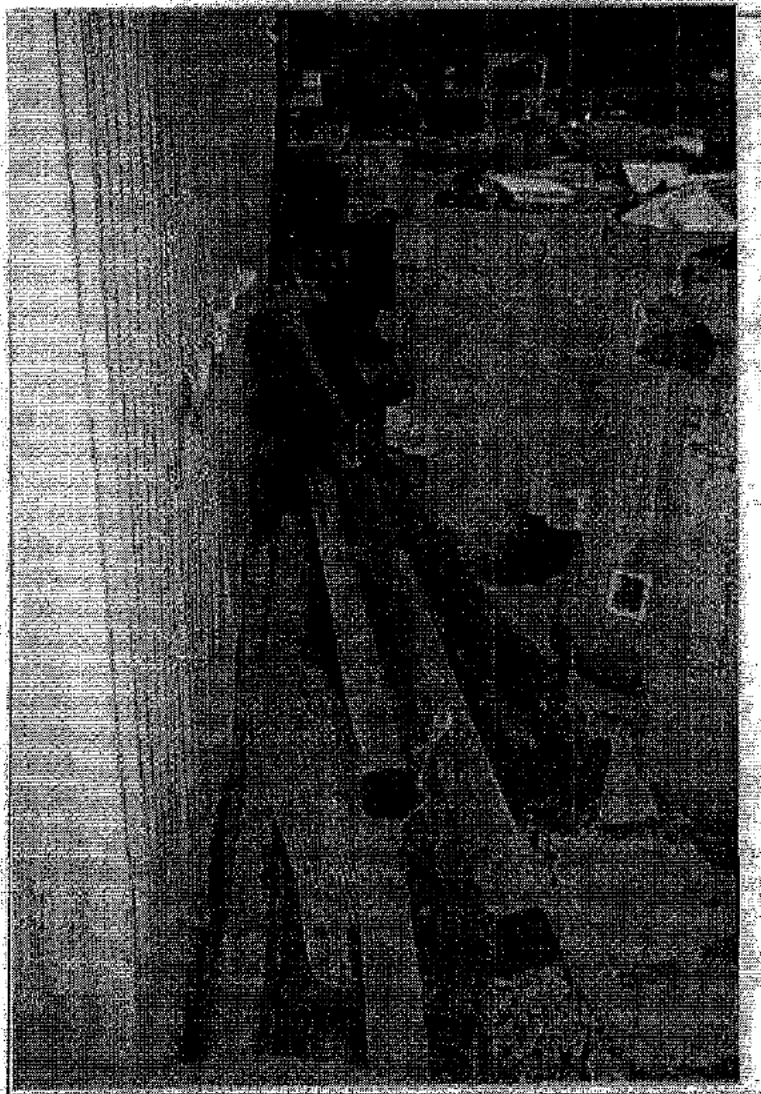
Photo No.
16
Neg. No.
15

Photographer/Witness W. Bigley/ K. Westberry
Date: 05/20/97 Time 10:30 Direction East
Description View along the north side of the shop. Note the staining and the condition of the transformers.
